RAILWAY ACCIDENT

Report on the Derailment
and subsequent Collision that
occurred on 31st December 1969
near Roade Junction

IN THE
LONDON MIDLAND REGION
BRITISH RAILWAYS

1971

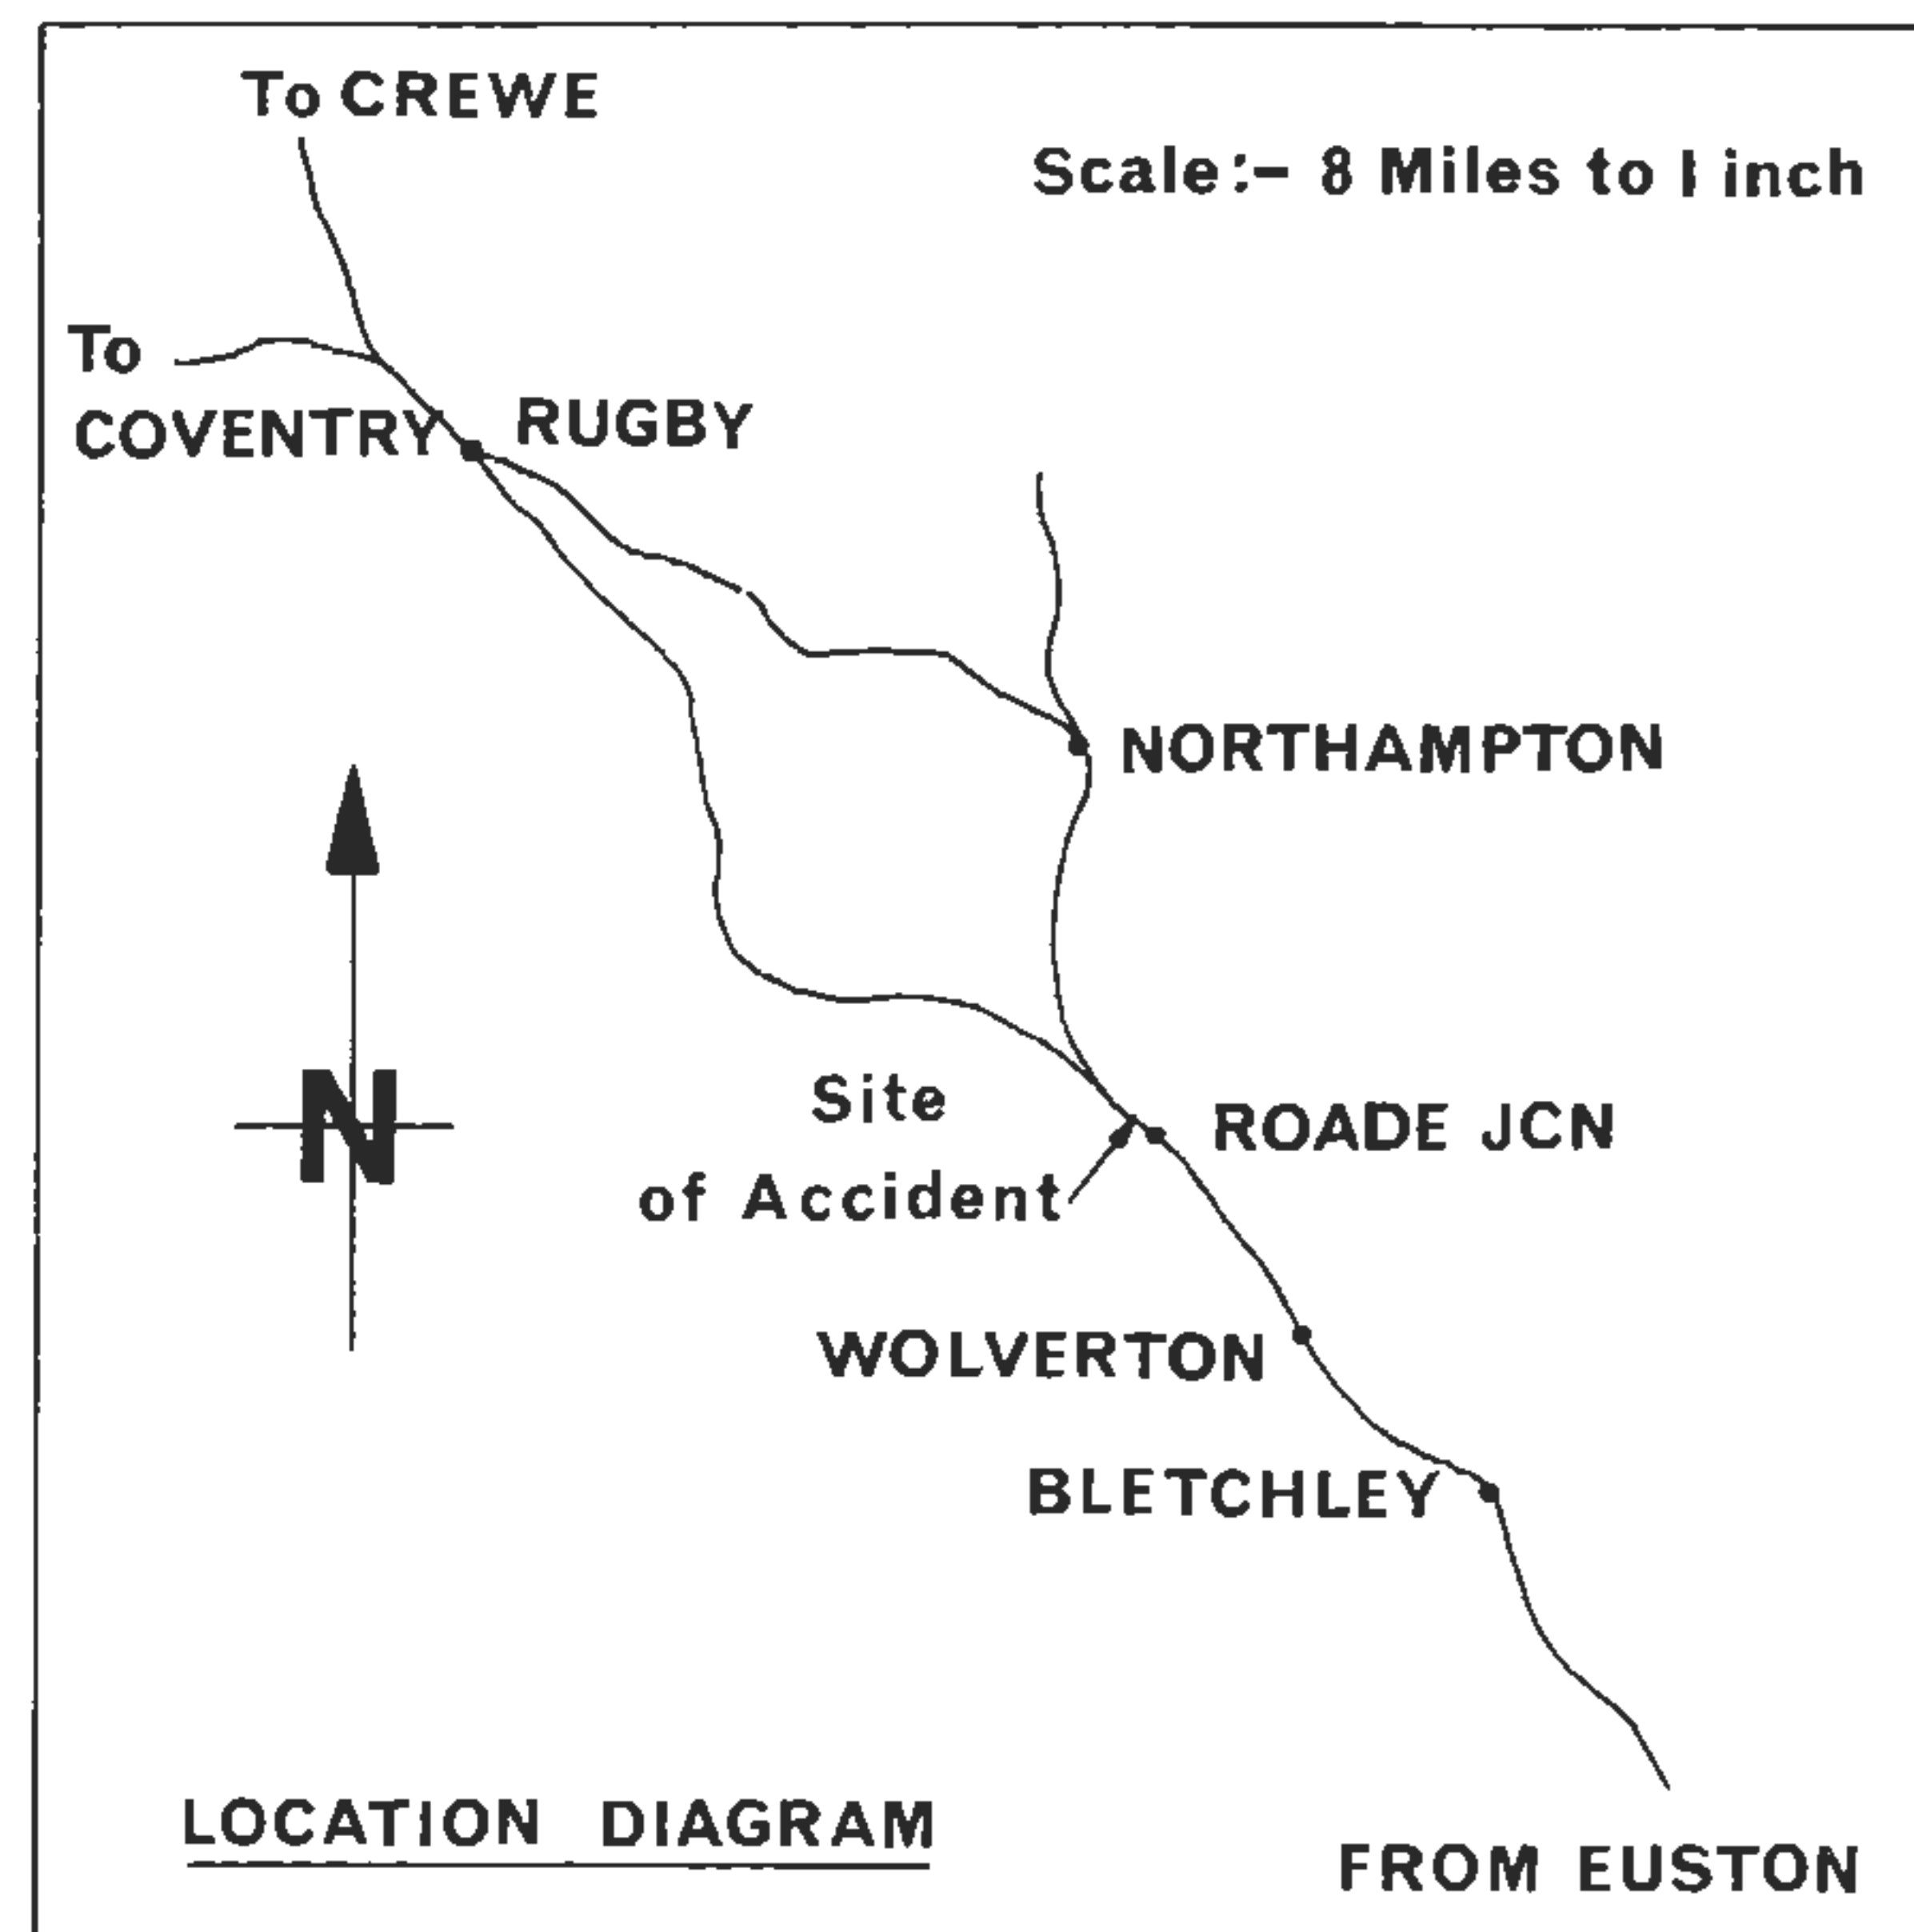
DERAILMENT AND COLLISION AT ROADE (LONDON MIDLAND REGION)

12. Damage to signal cables in the area caused failure of signals and loss of indication as shown on the diagram attached to this report.
